# TRANSIT ASSET MANAGEMENT PLAN

Adopted September 24, 2018

## Attachment 3.4 Facility Condition Rating Assessment

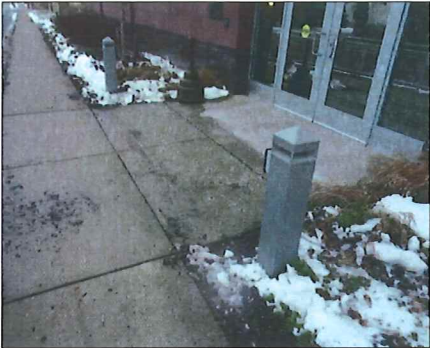
<p>No Visible Signs of Cracks</p>
<p>No visible signs of foundation cracks or damage was observed.</p>

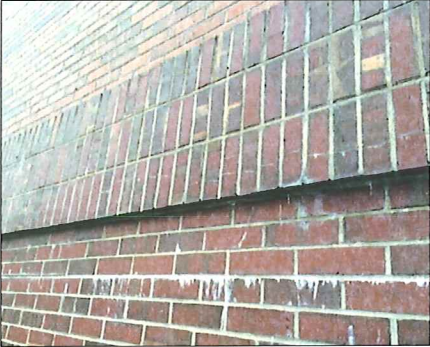
<p>Brick Soldier Course</p>
<p>The exterior masonry is in marginal condition. There are issues with the brick soldier course allowing moisture into the wall space. The cast stone roof cap also allows moisture into the wall assembly. These areas should be sealed or refaced with metal panels or new metal wall cap. Visible structural elements appear satisfactory.</p>		
<ul style="list-style-type: none"> <li><b>Wall Insulation</b></li> </ul>	<p><b>3: Adequate</b></p>

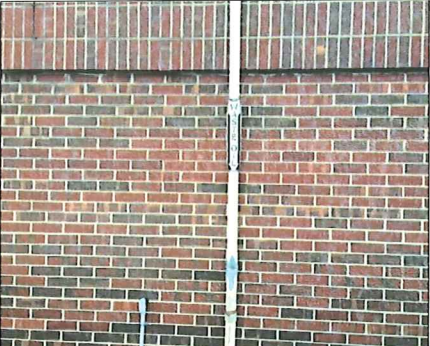
<p>Masonry Wall Construction</p>
<p>2010 ASHRAE Standard R-11.4 Continuous Insulation. Original building consists of 8-inch CMU, 1-inch rigid insulation and 4-inch face brick. This assembly has an assumed R-value of 5.55. The 2010 addition exterior walls are constructed with 8-inch concrete block, 2-inch air space and 2-inch rigid insulation with 4-inch face brick. This assembly has an assumed insulation value of R-15 or better.</p>

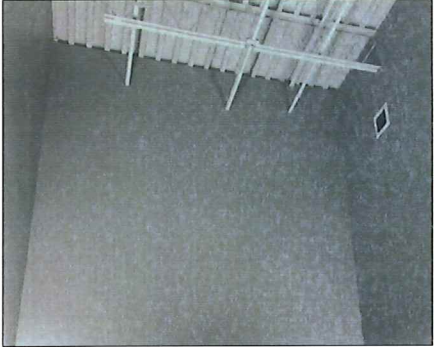
<p style="text-align: center;">Steel Joist and Metal Deck Construction</p>
<p>The original 1977 building structure consists of non-combustible concrete block, concrete columns and concrete roof structure (Type IIA). The 2010 addition consists of concrete block walls, steel columns and steel roof joists.</p>		
<ul style="list-style-type: none"> <li>• <b>Roof: Roof Surface, Gutters, Eaves, Skylights, Chimney Surrounds</b></li> </ul>	<p><b>3: Adequate</b></p>

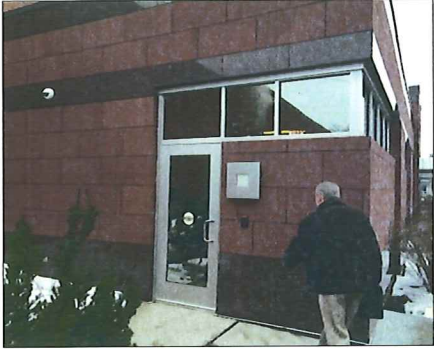
<p style="text-align: center;">Northeast Staff Entry</p>
<p>The 2010 addition was constructed with 1-inch insulated glass. A small number of older windows with original ¼ inch non-insulated glazing remain. 2010 addition exterior doors are aluminum with insulated glass and are satisfactory. A few remaining non-insulated, painted hollow metal doors are in borderline condition.</p>		
<ul style="list-style-type: none"> <li>• <b>Openings/Penetrations Are Properly Sealed</b></li> </ul>	<p><b>3: Adequate</b></p>

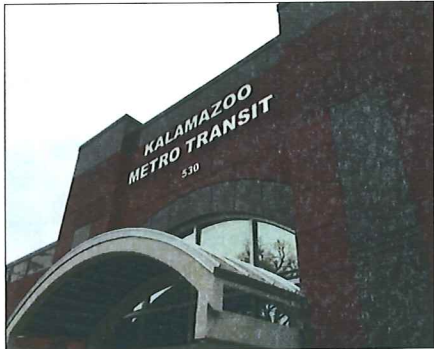
<p style="text-align: center;">Front Signage</p>
<p>The building signage is provided on the north side, northwest and southwest corners. No signage is located on the east side of the building.</p>

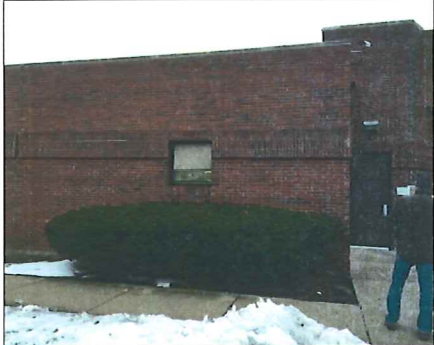
<p style="text-align: center;">West Side Staff Entry</p>
<p>The entry on the northwest corner is visible from the parking lot. The board room entry is not as visible. Public entries have sufficient sheltered canopies. The staff entry on the west side is not sheltered. The staff entry on the northeast side near the picnic table is not sheltered. Entrances and exits are at grade. At areas of sloped walks, handrails are provided.</p>		
<ul style="list-style-type: none"> <li><b>Daylighting</b></li> </ul>	<p><b>3: Adequate</b></p>

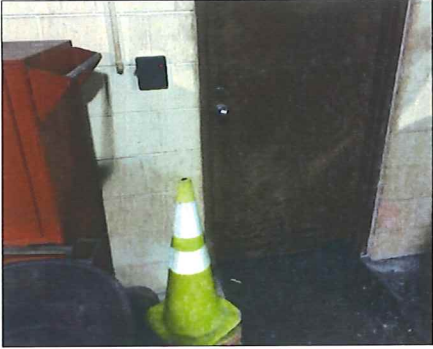
<p style="text-align: center;">Old Door, Knob Type in Hardware</p>
<p>The conditions of walls, doors and hardware is adequate. The 2010 addition is satisfactory. There is evidence of peeling paint &amp; peeling wall covering on walls. The bus service area needs painting. The doors are a mix of new (2010) with proper lever type hardware and old with non-complaint knob type hardware.</p>		
<ul style="list-style-type: none"> <li><b>Finishes: Materials Used on Walls, Floors and Ceilings</b></li> </ul>	<p><b>4: Good</b></p>

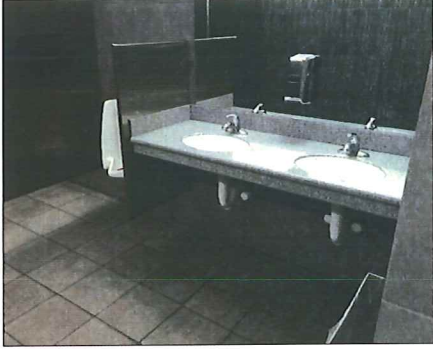
<p style="text-align: center;">Flooring Toilet Rooms</p>
<p>The condition of flooring and ceilings is good. The majority of the office area flooring was replaced in 2010. The flooring is in satisfactory condition. The majority of the office area ceilings were replaced in 2010. The ceilings are in satisfactory condition. The bus service area needs painting.</p>

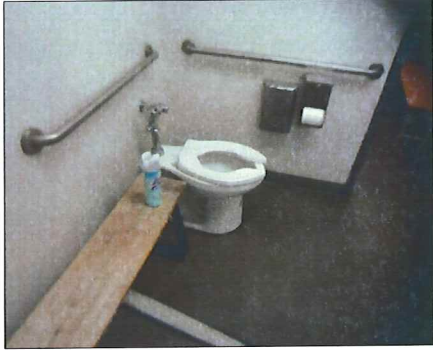
<p style="text-align: center;">Service Tech Toilet Rooms</p>
<p>The addition and drivers lounge toilet rooms were constructed/remodeled in 2010 and are in satisfactory condition. Service technician locker rooms are in borderline condition. Unisex storage area toilet room is in poor condition.</p>

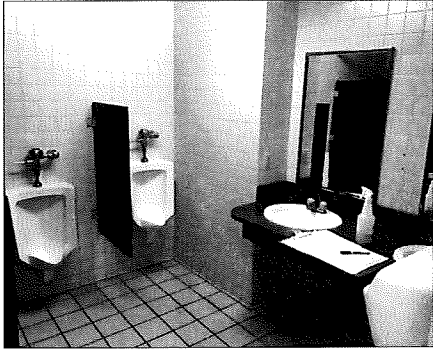
<p style="text-align: center;">Plumbing Fixtures</p>
<p>The condition of plumbing fixtures are adequate for building occupancy.</p>		
<ul style="list-style-type: none"> <li><b>Barrier Free Toilet Rooms</b></li> </ul>	<b>4: Good</b>

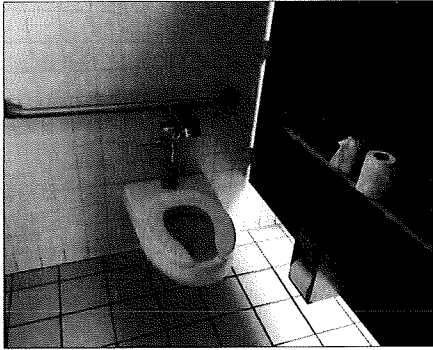
<p style="text-align: center;">Toilet Rooms</p>
<p>The toilet rooms are accessible. Toilet stalls do not contain a vertical grab bar (requirement added in 2012 Michigan Building Code adopted 9/1/2014)</p>		
<ul style="list-style-type: none"> <li><b>Water Distribution</b></li> </ul>	<b>3: Adequate</b>

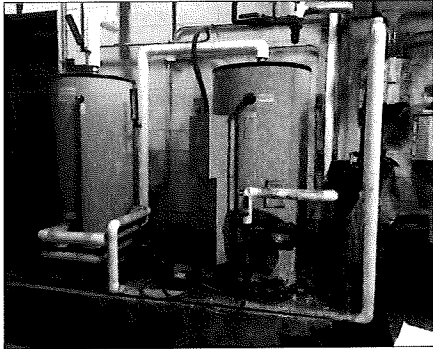
<p style="text-align: center;">Domestic Water Heating System</p>
<p>The condition of the internal water distribution system is adequate. The hot water recirculation line does not extend to showers.</p>

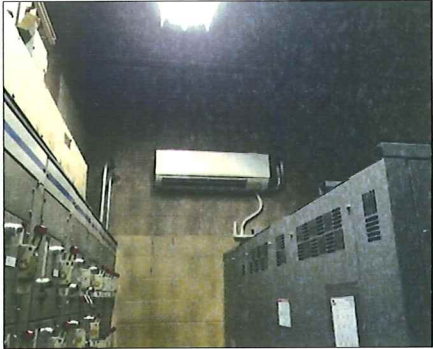
<p style="text-align: center;">Condensate Drain Over Electrical Gear</p>
<p>The condition of the sanitary system is adequate. The condensate drain is directly above electrical gear and should be relocated.</p>		
<ul style="list-style-type: none"> <li>Rain Water Drainage</li> </ul>	<p><b>4: Good</b></p>

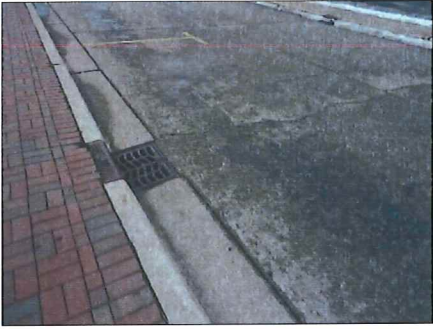
<p style="text-align: center;">Rain Water Drainage</p>
<p>The condition of storm system is good. There were no issues raised or identified.</p>		
<p>E. HVAC</p>	<p>TERM Rating</p>	<p>Photos</p>
<ul style="list-style-type: none"> <li>Energy Supply</li> </ul>	<p><b>4: Good</b></p>

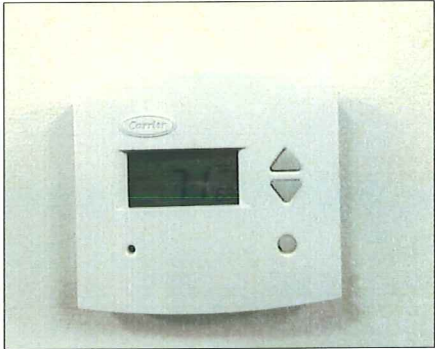
<p style="text-align: center;">Thermostat Controls</p>
<p>The condition of the controls is marginal. The control of the original HVAC equipment in the shop and garage is manual. Temperature control in the office area is inadequate.</p>		
<ul style="list-style-type: none"> <li><b>Ventilation</b></li> </ul>	<p><b>2: Marginal</b></p>

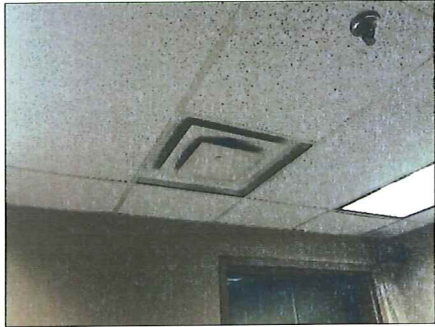
<p style="text-align: center;">Exhaust Fan</p>
<p>The indoor air quality in both the shop and garage is very poor. Select toilet room exhaust fans are not working. Ducts are dirty as evident from dust spots on the ceiling.</p>

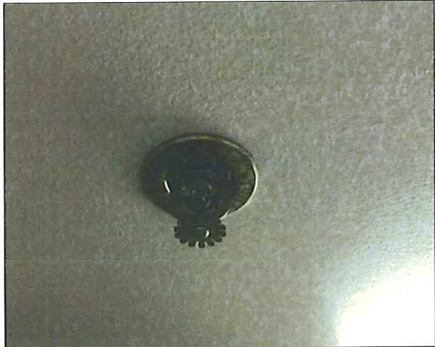
<p style="text-align: center;">Building is Fully Sprinkled</p>
<p>A fire sprinkler system is installed throughout the building.</p>		
<ul style="list-style-type: none"> <li>• <b>Fire Alarm</b></li> </ul>	<p><b>2: Marginal</b></p>

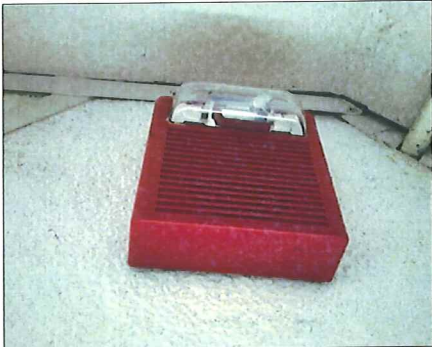
<p style="text-align: center;">Wall Device</p>
<p>Fire alarm system is out of date in some areas, some spaces have all mounted strobes attached to ceiling, coverage could be examined.</p>

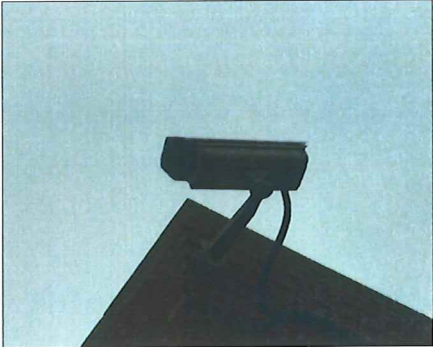
<p>Security Camera</p> </div>
<p>Security control is provided at entry points. Overhead door entry is not secure. Suggest access to be added to overhead doors with vehicles tags.</p>		
<ul style="list-style-type: none"> <li>• <b>Card Access</b></li> </ul>	<b>4: Good</b>	<b>NEED A PHOTO</b>
<p>EPS monitored access system is installed</p>		
<ul style="list-style-type: none"> <li>• <b>Egress Stairways</b></li> </ul>	<b>5: Excellent</b>	<b>NEED A PHOTO</b>
<p>Exit stairways (mezzanine levels) is code compliant.</p>

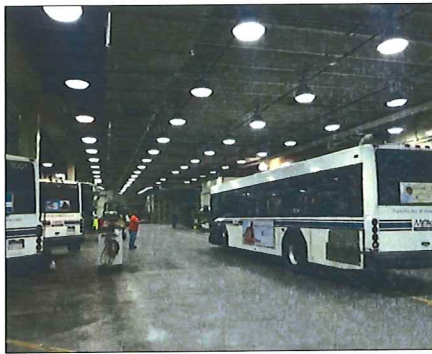
<p style="text-align: center;">Metal Halide Lighting</p>
<p>Lighting is primarily metal halide in the garage and workshop areas, mixture of different linear fluorescent and compact fluorescent in the office areas. Can be improved in aesthetics and energy utilization with LED fixtures.</p>

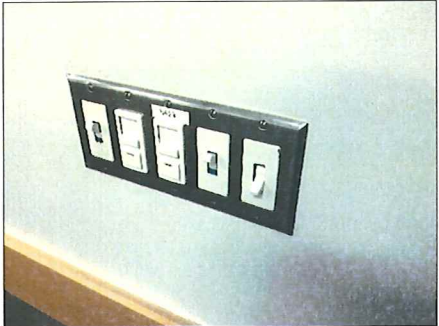
<p style="text-align: center;">Lighting Controls</p>
<p>Some newly added or renovated spaces are provided with occupancy sensors to meet energy code. There are many areas (older office and other storage rooms, etc.) that have no automatic lighting control.</p>		
<ul style="list-style-type: none"> <li>• <b>Condition of Receptacles and Circuiting</b></li> </ul>	<p><b>3: Adequate</b></p>

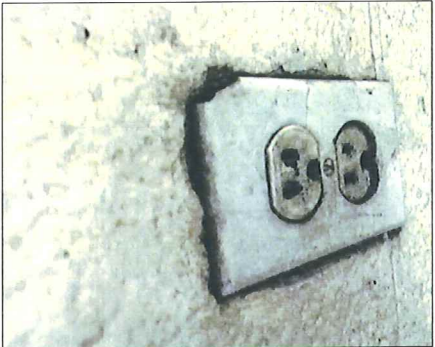
<p style="text-align: center;">Old Receptacle</p>
<p>There are worn and aging receptacles in areas that would be replaced in a renovation. Receptacles appear to meet code and should be replaced in the older parts of the building.</p>		
<ul style="list-style-type: none"> <li>• <b>Communications &amp; Security</b></li> </ul>	<p><b>3: Adequate</b></p>

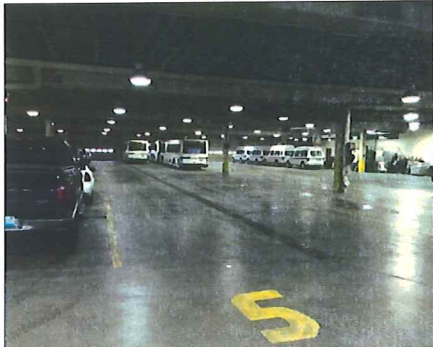
<p style="text-align: center;">Bus Storage</p>
<p>The roadways and driveways as well as associated signage, markings and equipment are satisfactory.</p>

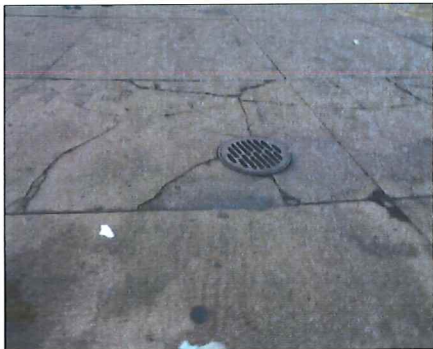
<p style="text-align: center;">Concrete Paving is Cracked</p>
<p>Vehicle concrete has cracks across large areas, but pavement is not spalling. Asphalt parking lot has cracking and some large settling cracks.</p>		
<ul style="list-style-type: none"> <li><b>On Site Parking</b></li> </ul>	<p><b>3: Adequate</b></p>

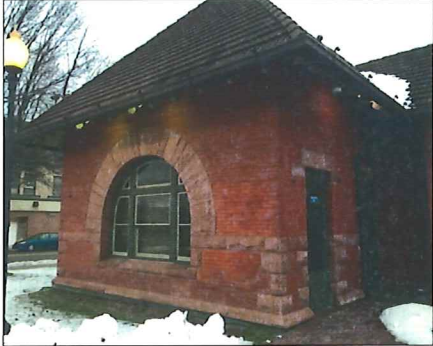
<p style="text-align: center;">Condition of the Visible Foundation</p>	
Condition of the visible foundations is satisfactory.			
<ul style="list-style-type: none"> <li><b>Basement</b></li> </ul>	<b>3: Adequate</b>

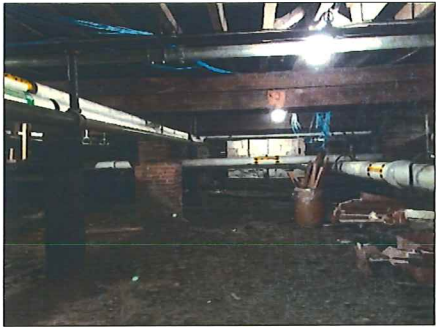
<p style="text-align: center;">Basement</p>	
The basement area is congested and dirty. Some areas of the floor slab need to be replaced.

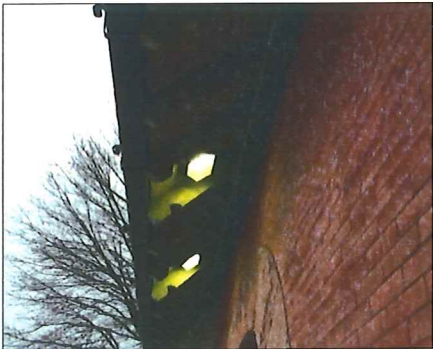
<p style="text-align: center;">Wood Framed Roof</p>	
The roof framing appears to be satisfactory. There is a section of the first-floor wood framing that needs to be replaced in the basement area.			
<ul style="list-style-type: none"> <li><b>Wall Insulation</b></li> </ul>	<b>3: Adequate</b>

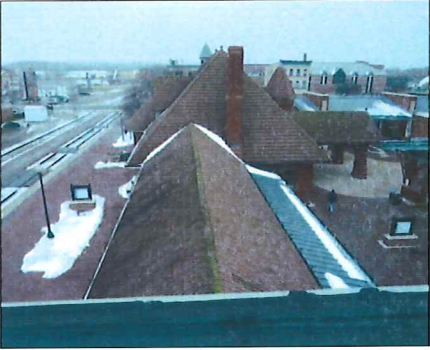
<p style="text-align: center;">Discoloration on Slate Roof</p>
<p>Good slate roof restored in 1987. There is evidence of some discoloration and staining that should be cleaned. The bus canopy has a metal panel roof system. The existing snow guards need to be replaced. There is some rubber roof membrane installed in 2006 that is in good condition.</p>

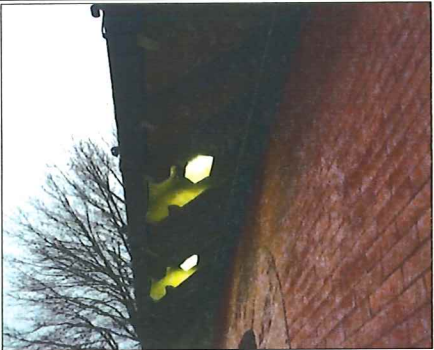
<p style="text-align: center;">Wood Framed Roof</p>
<ul style="list-style-type: none"> <li>Exterior: Windows, Doors, and All Finishes (paint, masonry)</li> </ul>	<p style="text-align: center;"><b>4: Good</b></p>
<p>The exterior masonry and stone is in satisfactory condition. There are some areas that need to be cleaned. The existing wood overhangs and soffits require continual maintenance and painting.</p>

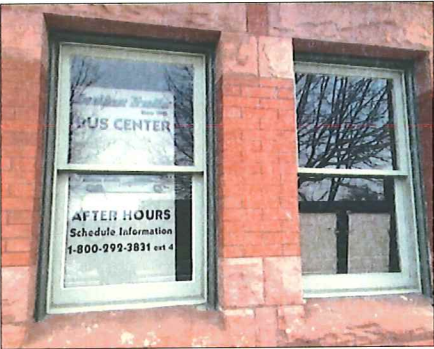
<p style="text-align: center;">Exterior Masonry</p>
<ul style="list-style-type: none"> <li>Openings/Penetrations Are Properly Sealed</li> </ul>	<p style="text-align: center;"><b>5: Excellent</b></p>
<p>No major openings, holes or penetrations were visible in the building envelope.</p>

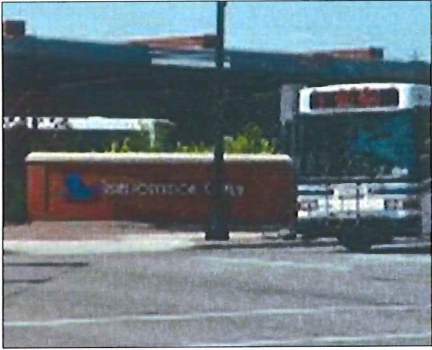
<p style="text-align: center;">Site Signage</p>	
<p>“Welcome to Kalamazoo” sign, track side seems a little celebratory. Directional signage is adequate. Transportation Center monument signs at each corner need new letters and lighting.</p>		<ul style="list-style-type: none"> <li>• <b>Building Entrances</b></li> </ul> <p>The entrances have good coverage over the bus area. The train station has good coverage at the main entries. There is no cover “track side”-passengers can stay inside.</p>

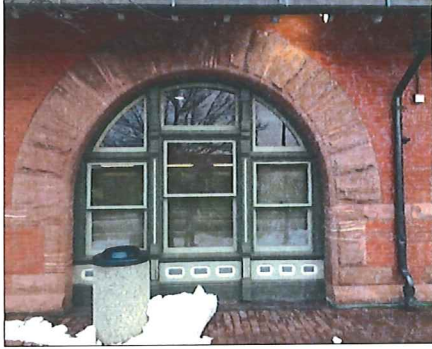
<p style="text-align: center;">Large Windows for Natural Daylighting</p>	
<p>The building has large windows on the north and south sides with an abundance of daylighting.</p>

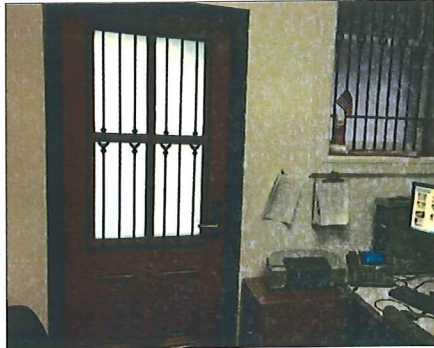
<p style="text-align: center;">Wood Doors</p>
<p>The walls are in satisfactory condition. The restored fire places are excellent. The wood paneling is excellent. The wood doors are in satisfactory condition. The hardware is the proper lever type.</p>

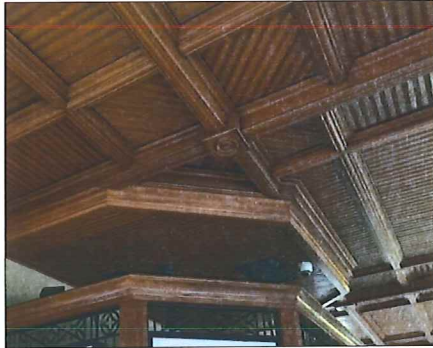
<p style="text-align: center;"><b>Wood Ceiling</b></p>
<p>The ceilings were restored/remodeled in 2006 and are in satisfactory condition. The wood ceiling in the waiting area is beautiful. The flooring was restored/remodeled in 2006 and is in satisfactory condition. The restored terrazzo flooring is satisfactory.</p>		
<p>D. Plumbing</p>	<p>TERM Rating</p>	<p>Photos</p>
<ul style="list-style-type: none"> <li><b>Condition of Toilet Rooms</b></li> </ul>	<p><b>4: Good</b></p>

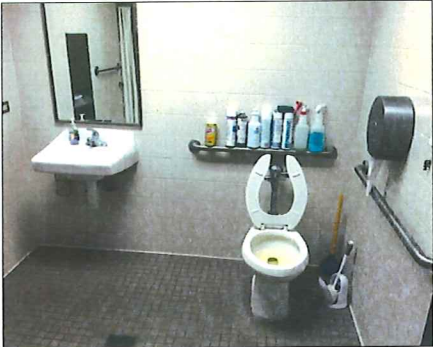
<p style="text-align: center;">Plumbing Fixtures</p>
<p>The plumbing fixtures are adequate for building occupancy. The sanitary line is undersized. Consider replacing the sanitary line during the next major renovation.</p>		
<ul style="list-style-type: none"> <li>• <b>Barrier Free Toilet Rooms</b></li> </ul>	<p><b>4: Good</b></p>

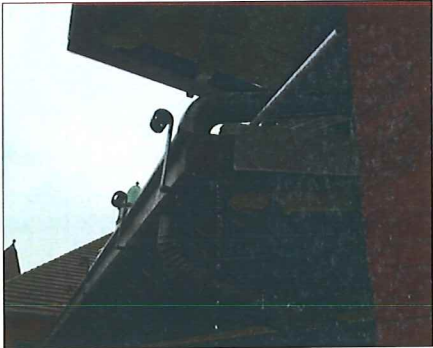
<p style="text-align: center;">Gutter and Downspouts</p>
<p>Downspouts create nuisance puddles in the pedestrian traffic area.</p>		
<p>E. HVAC</p>	<p>TERM Rating</p>	<p>Photos</p>
<ul style="list-style-type: none"> <li>Energy Supply</li> </ul>	<p><b>2: Marginal</b></p>

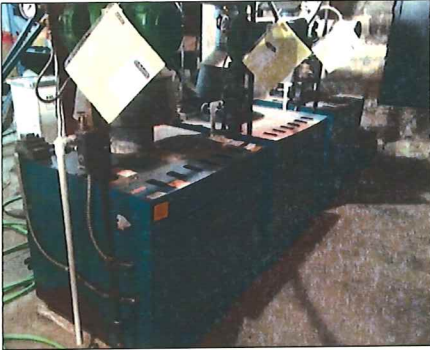
<p style="text-align: center;">Aged Heating Boilers</p>
<p>The boilers are aged. Poor gas pressure and flow rate. Cannot run all three boilers at one time.</p>

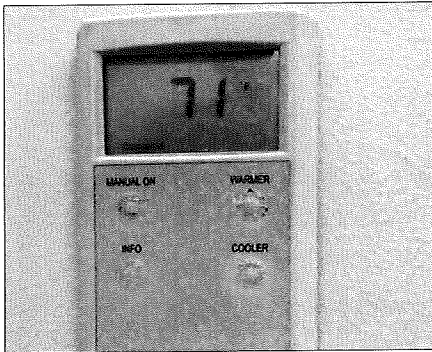
<p><b>Thermostat Controls</b></p> </div>
<p>The controls need revisions to meet set points. Consider energy saving controls for snowmelt system.</p>

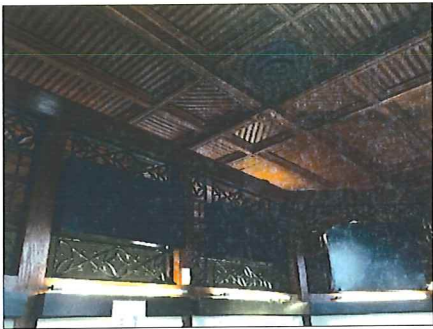
<p>Ventilation</p> </div>
<p>Poor ventilation and air distribution in main toilet rooms.</p>		
<ul style="list-style-type: none"> <li>Chimney and Vents</li> </ul>	<b>4: Good</b>	<div style="text-align: center;">

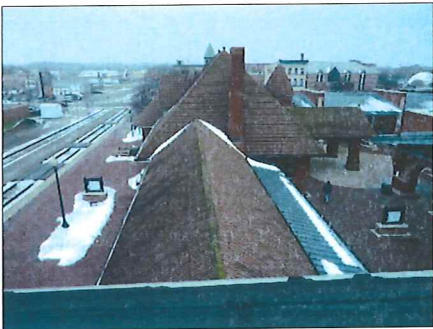
<p>Chimney</p> </div>
<p>There are some plumbing vent stacks and HVAC vents which are in satisfactory condition.</p>

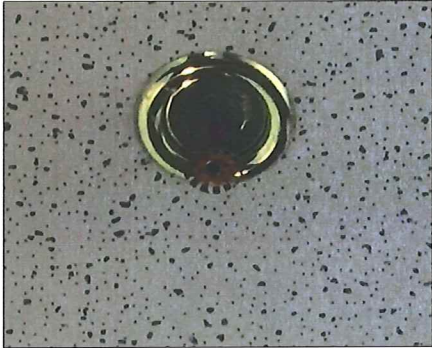
<p style="text-align: center;">Sprinklers</p>
<p>The building is fully sprinkled.</p>		
<ul style="list-style-type: none"> <li>• <b>Fire Alarm</b></li> </ul>	<b>4: Good</b>

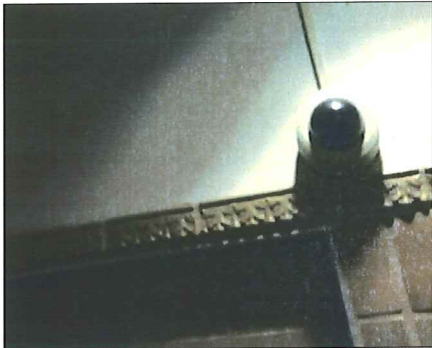
<p style="text-align: center;">Security Camera</p>
<p>There is a system in place but it is outdated. Recommend an update to IP using wide dynamic range cameras and network recording device.</p>

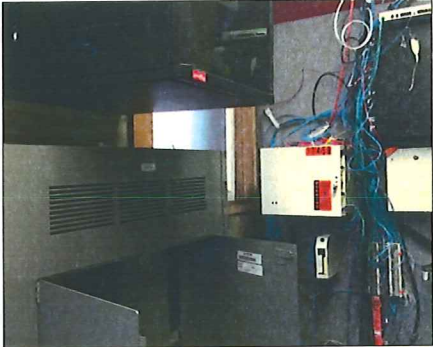
<p style="text-align: center;">Electrical Service</p>
<p>The distribution and branch panels are in great condition. There were a couple of panels that were not updated that could use replacement.</p>		
<ul style="list-style-type: none"> <li>Condition of Electrical Service</li> </ul>	<b>5: Excellent</b>

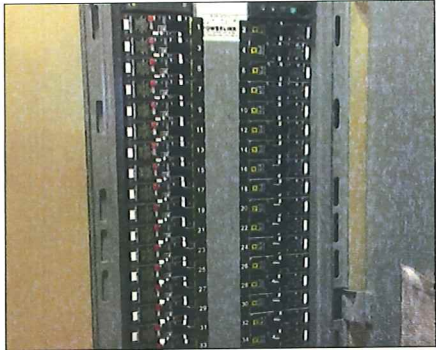
<p style="text-align: center;">Electrical Panel</p>
<p>The electrical was renovated in the 2004-2006 renovation. The service is fed from a Consumers pad mount transformer serving a 1200A 208V main panel. The panel is equipped with metering and surge protection.</p>

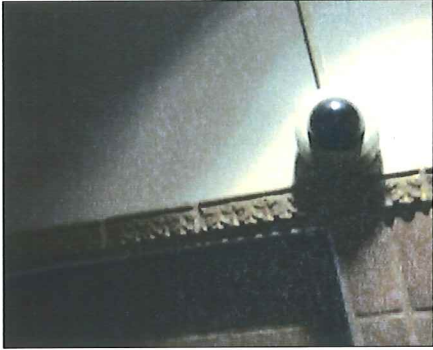
<p style="text-align: center;">Security Camera</p>	
<p>The facility is a public building. Access points are not secured. They can be monitored by staff. Suggest account control be added to the storage area.</p>	<ul style="list-style-type: none"> <li><b>Other Electrical System-Related Pieces Such As Lightning Protection, Generators, and Emergency Power</b></li> </ul>	<p><b>4: Good</b></p>

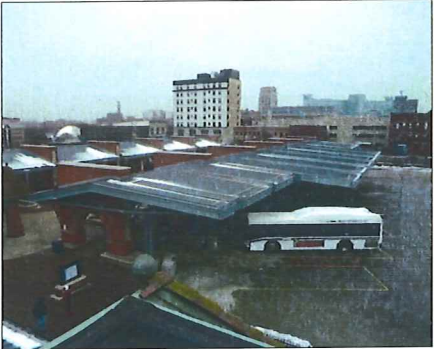
<p style="text-align: center;">Site</p>	
<p>The site is very small and there is lots of activity taking place in one location. No room for growth.</p>
