# TRANSIT ASSET MANAGEMENT PLAN

Adopted September 24, 2018

## Attachment 3.4 Facility Condition Rating Assessment

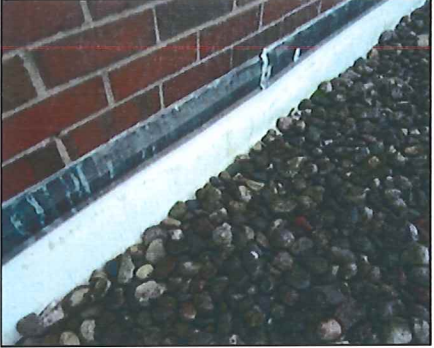
<p style="text-align: center;">Ballasted Membrane Roof</p>
<p>The original building area roof is stone ballasted membrane installed in 2002 with an assumed warranty period of 25 years (expiring in 2027). The 2010 addition is a membrane roof with an assumed warranty period of 20 years (expiring in 2030).</p>		
<ul style="list-style-type: none"> <li>• <b>Roof Insulation</b></li> </ul>	<p><b>5: Excellent</b></p>

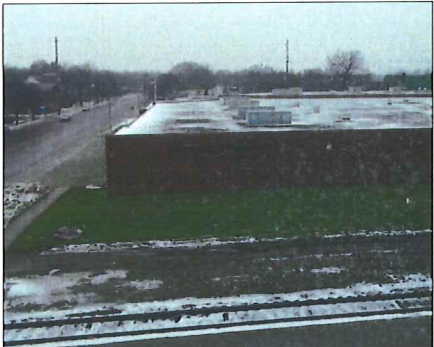
<p style="text-align: center;">Roof of Bus Storage/Service/Administration</p>

<p>2010 ASHRAE Standard requires an R-20 value. The addition in 2010 and re-roof in 2002 is assumed to have a minimum of 4 inches of rigid insulation.</p>

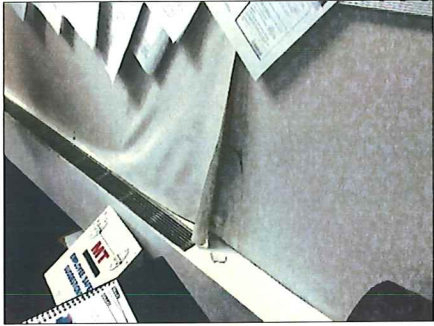
<p style="text-align: center;">Peeling Wallpaper</p>
<p>No major openings, holes or penetrations were visible in the building envelope. Peeling paint and wallpaper are a good indication there is evidence of water infiltration in the wall assembly. See superstructure.</p>

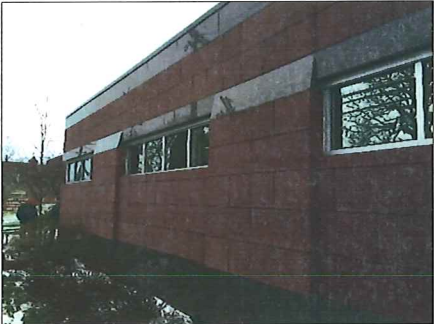
<p style="text-align: center;">Exterior Windows</p>
<p>Original building has poor daylighting. The 2010 addition has large windows, skylights with good daylighting.</p>		
<ul style="list-style-type: none"> <li><b>Overall Curb Appeal</b></li> </ul>	<p><b>4: Good</b></p>

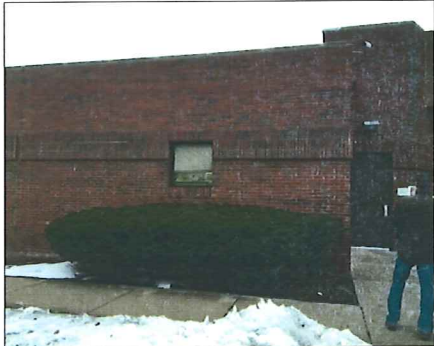
<p style="text-align: center;">Exterior Walls</p>

<p>The overall curb appeal is satisfactory. The 2010 addition is clean and contemporary. The remaining masonry exterior walls are satisfactory.</p>

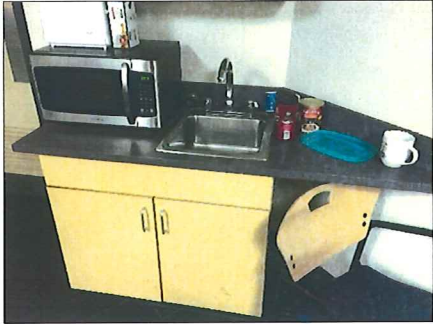
<p style="text-align: center;">Kitchen Area</p>
<p>Staff break room was added in 2010 and is in satisfactory condition. Drivers lounge area is in borderline condition.</p>		
<ul style="list-style-type: none"> <li>• <b>Condition of Casework</b></li> </ul>	<p><b>4: Good</b></p>

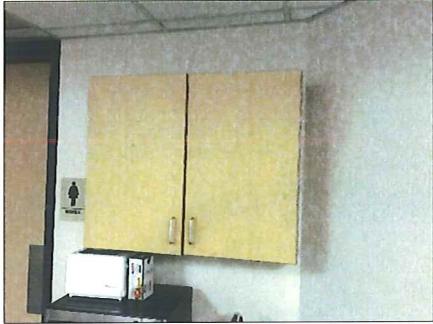
<p style="text-align: center;">Casework</p>
<p>Building in casework appear to be satisfactory.</p>		
<ul style="list-style-type: none"> <li>• <b>Condition of Visual Displays</b></li> </ul>	<p><b>4: Good</b></p>

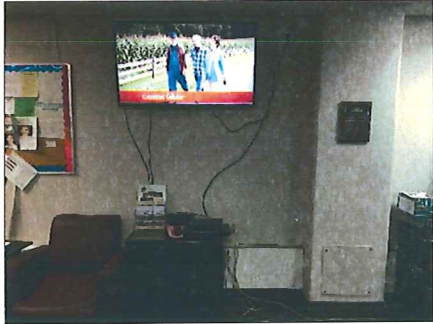
<p style="text-align: center;">Television</p>
<p>Visual display boards, employee notice areas, tack boards and TV monitors appear satisfactory.</p>		
<ul style="list-style-type: none"> <li>• <b>Condition of Lockers</b></li> </ul>	<p><b>4: Good</b></p>

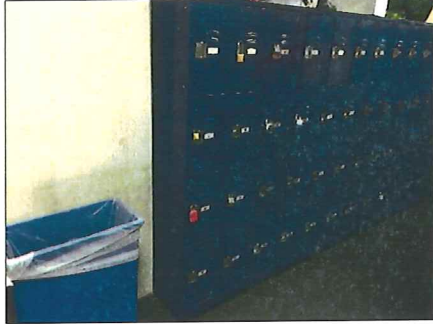
<p style="text-align: center;">Staff Lockers</p>

<p>Lockers appear to be satisfactory</p>

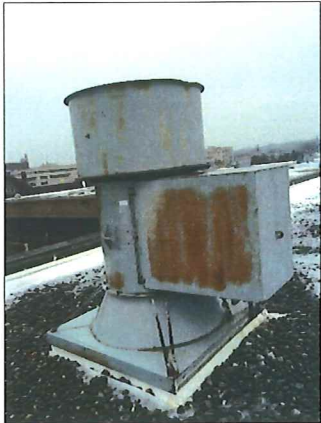
<ul style="list-style-type: none"> <li><b>Air Handling Equipment</b></li> </ul>	<p><b>2: Marginal</b></p>

<p style="text-align: center;">Air Handling Equipment</p>
<p>The makeup air units and original exhaust fan have served their useful life and should be considered for replacement within 5 years.</p>		
<ul style="list-style-type: none"> <li><b>Testing, Balancing, Controls and Instrumentation</b></li> </ul>	<p><b>2: Marginal</b></p>

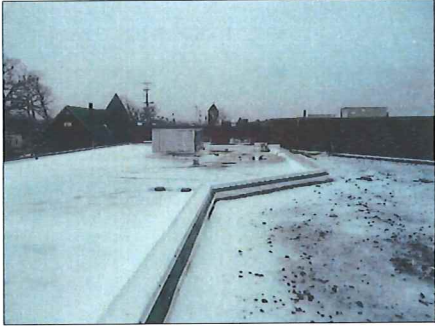
<p style="text-align: center;">Roof of Administrative Building</p>
<p>There are some plumbing vent stacks and HVAC vents which are in satisfactory condition.</p>		
<p>F. Fire Protection/Life Safety</p>	<p>TERM Rating</p>	<p>Photos</p>
<ul style="list-style-type: none"> <li>• <b>Sprinklers</b></li> </ul>	<p><b>5: Excellent</b></p>

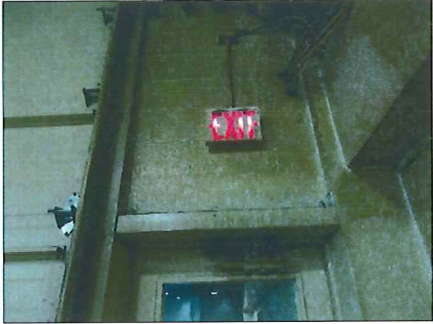
<p style="text-align: center;">Exit Door</p>
<p>Exit doors open outward and are provided with panic type hardware. Exiting is code compliant. Corridor egress routes are code compliant.</p>		
<ul style="list-style-type: none"> <li>• <b>Hydrants and Other Fire Protection Specialties</b></li> </ul>	<b>3: Adequate</b>

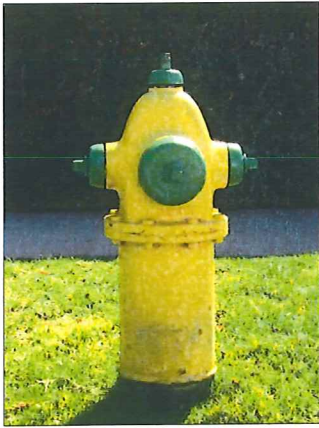
<p style="text-align: center;">Fire Hydrant</p>
<p>The hydrants and other fire protection is satisfactory. The building is on the City of Kalamazoo water supply with adequate hydrant locations.</p>		
<b>G. Electrical</b>	<b>TERM Rating</b>	<b>Photos</b>
<ul style="list-style-type: none"> <li>• <b>Electrical Service &amp; Distribution</b></li> </ul>	<b>3: Adequate</b>

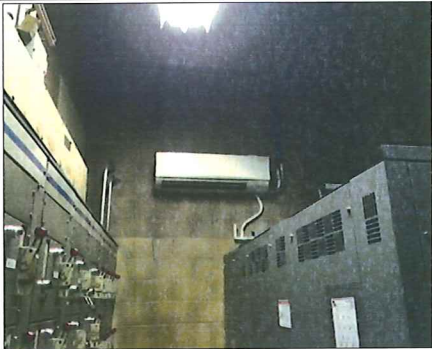
<p>The conditions / capacity of the distribution and branch panels is adequate. The distribution and branch panels vary. There are original panels that could use cleaning and reworking, tightening of the covers, lack of surge protectors.</p>

<p style="text-align: center;">Electrical Service</p>	
<ul style="list-style-type: none"> <li><b>Condition of Electrical Service</b></li> </ul>	<p><b>5: Excellent</b></p>

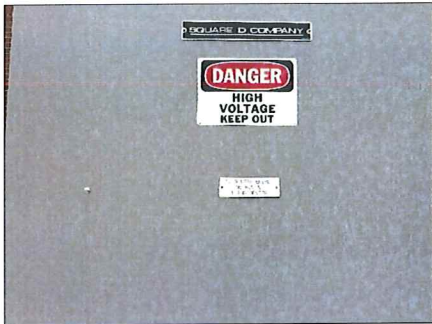
<p style="text-align: center;">Square D Transformer</p>
<p>Facility substation consists of a new Square D 750 kVA 8320/480 dry type transformer serving a new main distribution panel, 1200A main with metering.</p>		
<ul style="list-style-type: none"> <li><b>Lighting &amp; Branch Wiring (Interior and Exterior)</b></li> </ul>	<p><b>3: Adequate</b></p>

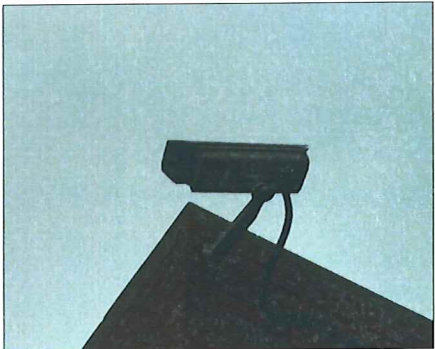
<p style="text-align: center;">Security Camera</p>

<p>A security camera system is installed. The camera and recording system is outdated. An update is recommended to IP WDR cameras</p>

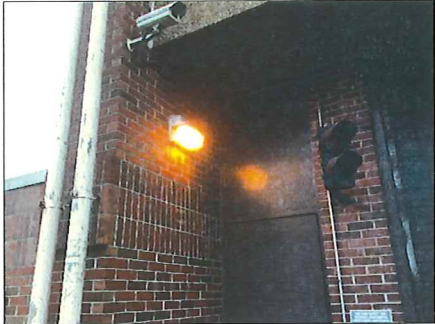
<p style="text-align: center;">Security Lighting</p>
<p>Emergency lighting is provided and meets current egress requirements. Emergency lighting is provided with double head emergency battery packs. Any renovation would incorporate emergency into the normal light.</p>

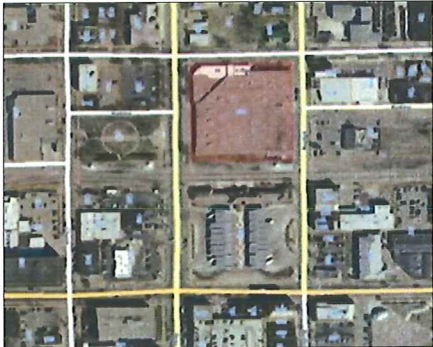
<p style="text-align: center;">Site Aerial</p>
<p>There is minimum area for expansion. The site is maximized. The site is stable with no signs of erosion. The site drains to the city streets. The street curb and gutters have areas of surface water ponding.</p>		
<ul style="list-style-type: none"> <li>• <b>Roadways/Driveways and Associated Signage, Markings, and Equipment</b></li> </ul>	<p><b>3: Adequate</b></p>

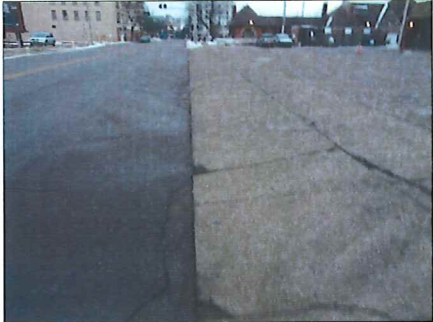
<p style="text-align: center;">Entrance/Exit</p>
<p>The majority of the facility traffic is designed to pull through. There is minimal backup.</p>		
<ul style="list-style-type: none"> <li><b>Parking Lots and Associated Signage, Markings, and Equipment</b></li> </ul>	<p><b>3: Adequate</b></p>

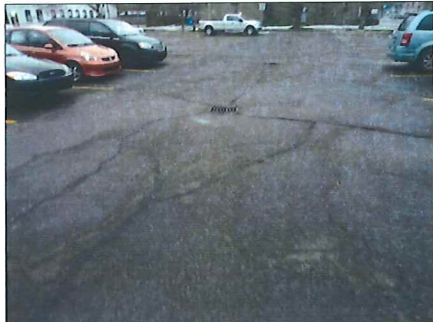
<p style="text-align: center;">Parking Lot Across the Street</p>
<p>There is an approximate 50 car parking lot across the street that does not provide sufficient parking. Minimal parking adjacent to the building. Bollards are needed to protect the building.</p>

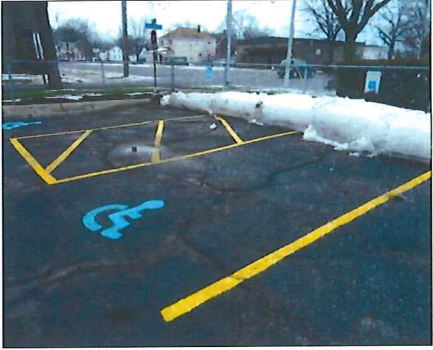
<p>Barrier free is provided in the lot across the street. There are two accessible spaces of 49 non-accessible spaces provided. No barrier free parking is adjacent to the building. Accessible walks are excellent.</p>

<p style="text-align: center;">Barrier Free Parking</p>	
<ul style="list-style-type: none"> <li>• <b>Pedestrian Areas and Associated Signage, Markings, and Equipment</b></li> </ul>	<p><b>3: Adequate</b></p>

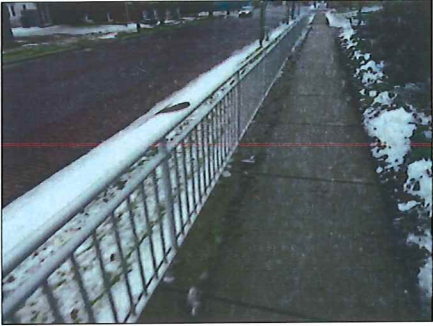
<p style="text-align: center;">Pedestrian Sidewalk</p>
<p>Paved surfaces include adequate sidewalks with crosswalks, curb cuts, etc. City streets contain cross walks at intersections. The west parking lot does not have a dedicated cross walk to the building entry. The separation of bus, car and pedestrian traffic is adequate for the safety of the occupants.</p>		
<ul style="list-style-type: none"> <li>• <b>Site Development Such as Fences, Walls, and Miscellaneous Structures</b></li> </ul>	<p><b>3: Adequate</b></p>

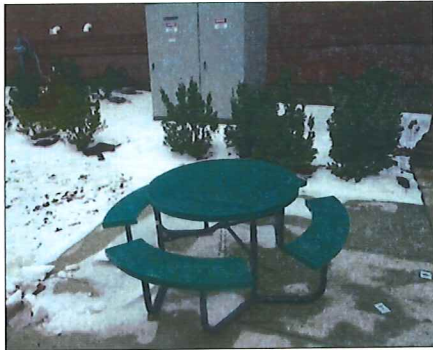
<p style="text-align: center;">Picnic Table Area</p>

<p>Outdoor facilities are adequate. Picnic table area appears to be satisfactory.</p>		
<ul style="list-style-type: none"> <li>• <b>Landscaping and Irrigation</b></li> </ul>	<p><b>4: Good</b></p>

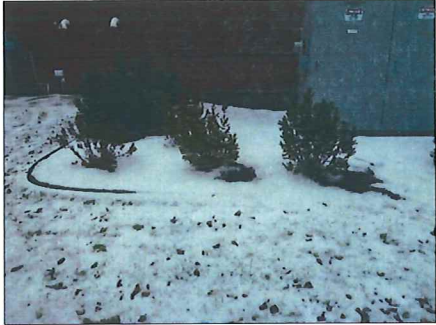
<p>Landscaping is irrigated and appears to be well maintained.</p>

<p style="text-align: center;">Landscaping</p>
<ul style="list-style-type: none"> <li>• <b>Site Utilities</b></li> </ul>	<p><b>3: Adequate</b></p>
<p>Water, sanitary and sewer is provided by the City of Kalamazoo. Natural gas distribution is provided by Consumers.</p>

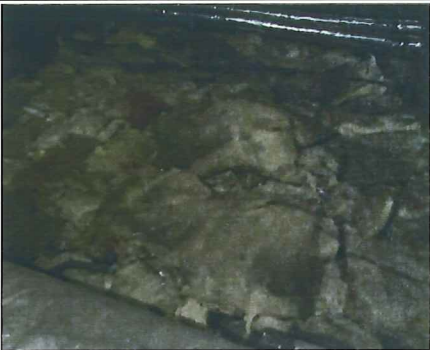
<p style="text-align: center;">Insulation in Attic</p>	
<ul style="list-style-type: none"> <li>• <b>Structure Combustibility</b></li> </ul>	<p><b>3: Adequate</b></p>

<p>2010 ASHRAE Standard R-11.4. Continuous insulation. Original building consists of interior drywall, metal studs (assumed batt insulation) 8-inch masonry and 4-inch face brick. This assembly has an assumed R-value of R-8.</p>

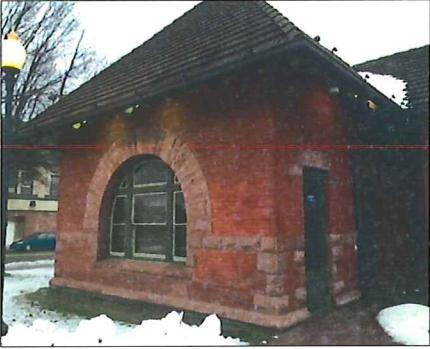
<p style="text-align: center;">Exterior Masonry and Stone Bearing Walls</p>
<p>The structure is wood framed roof and floor construction with masonry exterior bearing walls.</p>		
<ul style="list-style-type: none"> <li>• <b>Roof: Roof Surface, Gutters, Eaves, Skylights, Chimney Surrounds</b></li> </ul>	<p><b>4: Good</b></p>

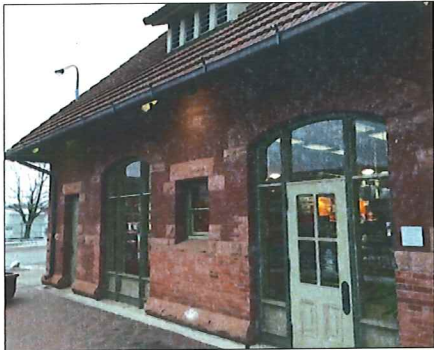
<p style="text-align: center;">Building Envelope</p>

<p style="text-align: center;">Exterior Masonry</p>
<ul style="list-style-type: none"> <li>Openings/Penetrations Are Properly Sealed</li> </ul>	<p style="text-align: center;"><b>5: Excellent</b></p>
<p>No major openings, holes or penetrations were visible in the building envelope.</p>

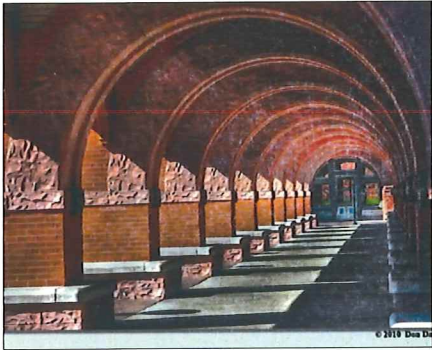
<p style="text-align: center;">Coverage Over Bus Area</p>
<ul style="list-style-type: none"> <li>• <b>Daylighting</b></li> </ul>	<b>10: Excellent</b>

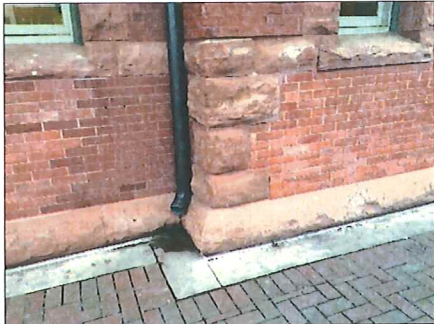
<p style="text-align: center;">Downspout on Transportation Center</p>
<p>The gutters and downspouts are in good shape however the downspouts create ponding on the walkways.</p>		
<ul style="list-style-type: none"> <li>• <b>Overall Curb Appeal</b></li> </ul>	<b>5: Excellent</b>

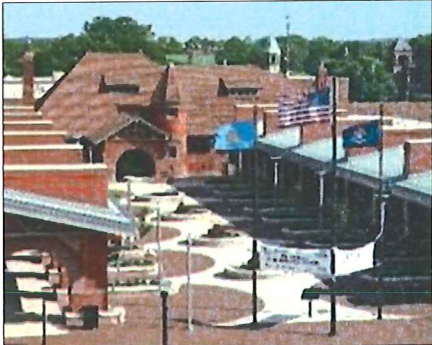
<p style="text-align: center;">Beautiful Facility</p>
<p>It is beautiful, iconic, historic facility.</p>

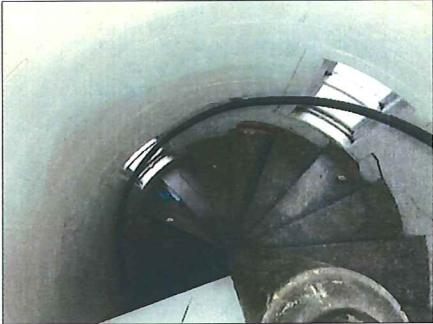
<p style="text-align: center;"><b>Basement Stairs</b></p>
<p>The stairs are for basement and attic access for mechanical purposes only.</p>		
<ul style="list-style-type: none"> <li><b>Finishes: Materials Used on Walls, Floors and Ceilings</b></li> </ul>	<p><b>4: Good</b></p>

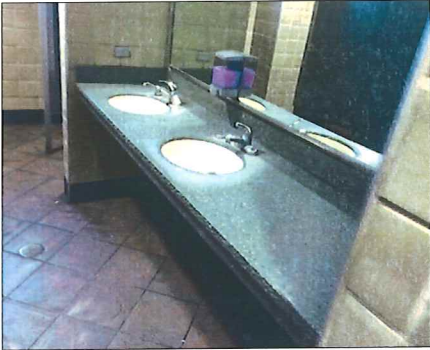
<p style="text-align: center;"><b>Toilet Rooms</b></p>

<p>Toilet rooms were remodeled in 2006 and are in satisfactory condition. There are some signs of damage due to vandalism on the toilet partitions.</p>

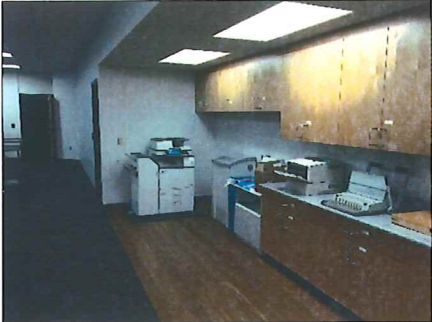
<p style="text-align: center;">Kitchen Area</p>
<p>The kitchen area in the café contains 3-compartment sink for cleaning and disinfecting. The area is in satisfactory condition.</p>		
<ul style="list-style-type: none"> <li>• <b>Condition of Casework</b></li> </ul>	<p><b>4: Good</b></p>

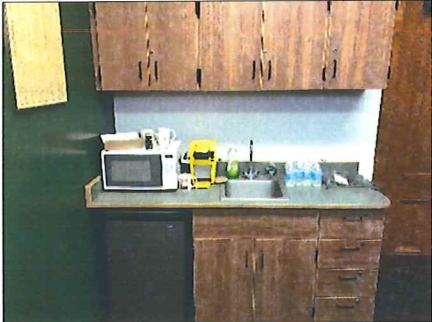
<p style="text-align: center;">Casework and Countertops</p>
<p>The casework, countertops and other built in items are satisfactory.</p>		
<ul style="list-style-type: none"> <li>• <b>Condition of Visual Displays</b></li> </ul>	<p><b>5: Excellent</b></p>

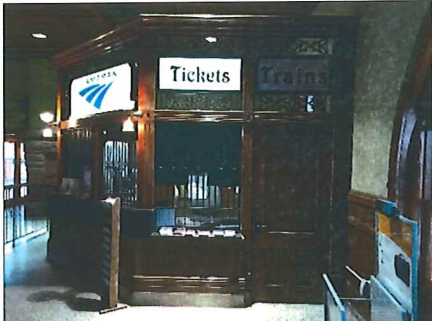
<p style="text-align: center;">Visual Displays</p>
<p>The visual displays, room signage, way finding signage is excellent.</p>

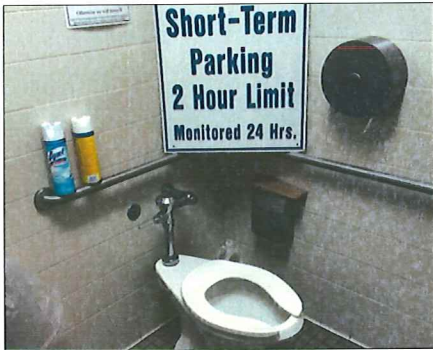
<p style="text-align: center;">Accessible Toilets</p>
<p>The toilet rooms are accessible. The toilet stalls do not contain a vertical grab bar (requirement add in 2012 Michigan Building Code adopted 9/1/2014).</p>		
<ul style="list-style-type: none"> <li>• <b>Water Distribution</b></li> </ul>	<p><b>4: Good</b></p>

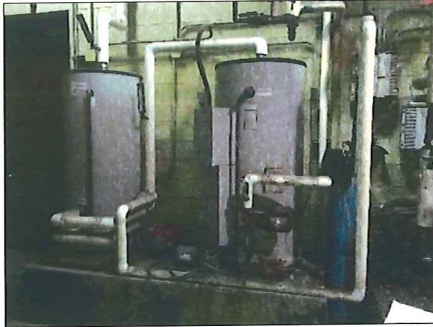
<p style="text-align: center;">Water Distribution</p>
<p>The condition of the internal water distribution is satisfactory. No issues raised or identified.</p>

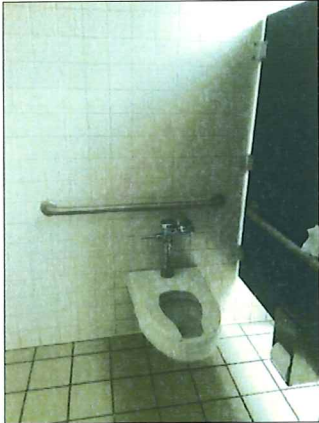
<p style="text-align: center;">Public Toilet Room</p>
<p>The condition of the sanitary waste is satisfactory. No issues raised or identified.</p>		
<ul style="list-style-type: none"> <li>Rain Water Drainage</li> </ul>	<p><b>2: Marginal</b></p>

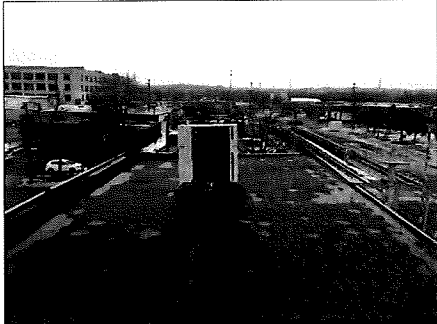
<p><b>Cooling Condenser</b></p> </div>
<p>No issues raised or identified.</p>		
<ul style="list-style-type: none"> <li>• <b>Heating / Cooling Generation and Distribution Systems</b></li> </ul>	<p><b>2: Marginal</b></p>	
<p>The main lobby is cold/hot when passengers are entering and exiting the building. Radiant heat is not keeping up with the load at the east end. Some radiant panels are running wild. Storage room behind vending is cold (west end).</p>		
<ul style="list-style-type: none"> <li>• <b>Testing, Balancing, Controls and Instrumentation</b></li> </ul>	<p><b>3: Adequate</b></p>	<div style="text-align: center;">

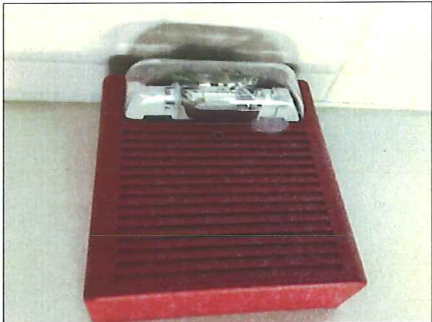
<p style="text-align: center;">Fire Alarm</p>
<p>Noticed a few power supplies that need to be on dedicated circuits.</p>		
<ul style="list-style-type: none"> <li>• <b>Security Access</b></li> </ul>	<b>2: Marginal</b>

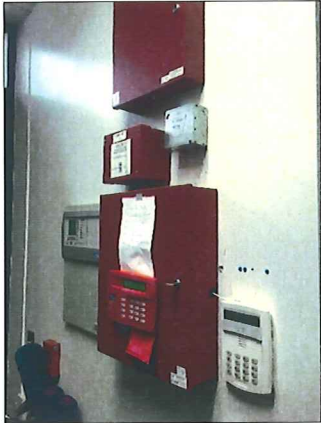
<p style="text-align: center;">Security Panel</p> </div>
<p>A card access is provided. Office areas, Consumer's service, Amtrak area and the concessions area are accessed by manual key.</p>		
<ul style="list-style-type: none"> <li>• <b>Egress Stairway</b></li> </ul>	<p><b>10: Excellent</b></p>	<div style="text-align: center;">

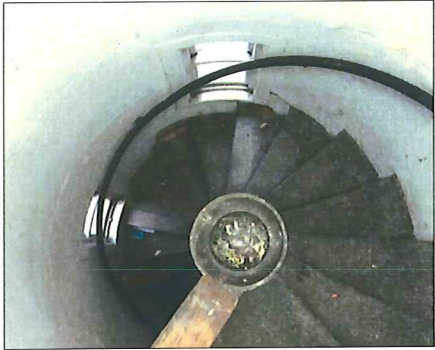
<p style="text-align: center;">Spiral Stair For Mechanical Room</p> </div>
<p>Egress stairway from the mechanical attic is compliant.</p>		
<ul style="list-style-type: none"> <li>• <b>Exit Door</b></li> </ul>	<p><b>5: Excellent</b></p>	<div style="text-align: center;">

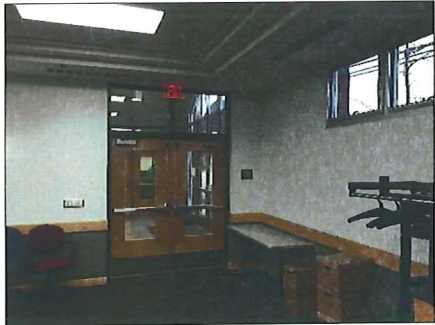
<p style="text-align: center;">Exit Door</p> </div>
<p>Exit doors are code compliant.</p>

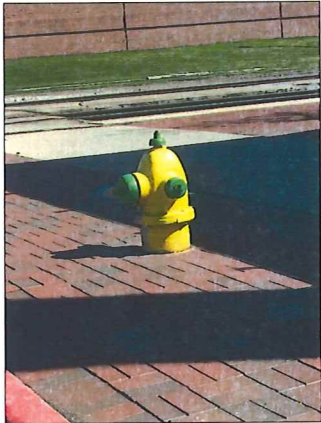
<p style="text-align: center;">Fire Hydrant</p>
<p>The hydrants and other fire protection is satisfactory. The building is on the City of Kalamazoo water supply with adequate hydrant locations.</p>

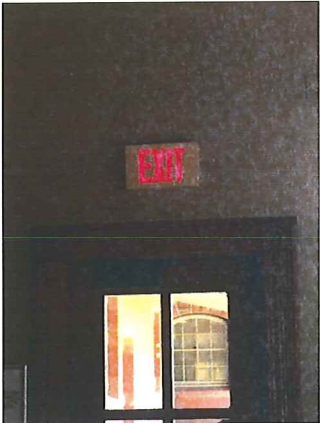
<p style="text-align: center;">Exit Sign</p>	
<p>This building does not have an emergency generator system supplying backup power.</p>	<p>H. Site</p>	<p>TERM Rating</p>	<p>Photos</p>
<ul style="list-style-type: none"> <li><b>General Site</b></li> </ul>	<p><b>2: Marginal</b></p>

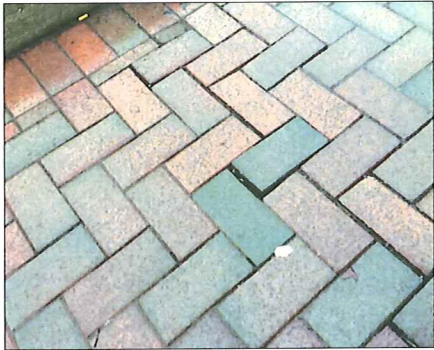
<p style="text-align: center;">Uneven Brick Pavers</p>
<p>Some minor cracks in vehicle concrete. Some minor un even brick pavers.</p>		
<ul style="list-style-type: none"> <li><b>Vehicular Entrances and Exits</b></li> </ul>	<p><b>3:</b> <b>Adequate</b></p>

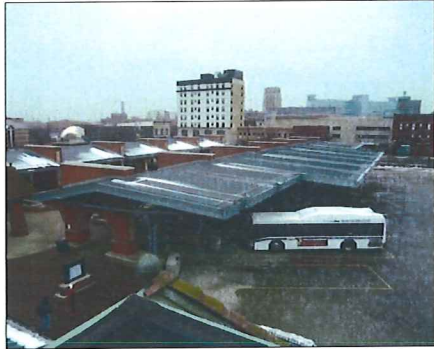
<p style="text-align: center;">Site</p>
<p>The busses back out of the loading parking spaces. The bus entrance is very near the intersection at Kalamazoo Ave.</p>		
<ul style="list-style-type: none"> <li><b>Parking Lots and Associated Signage, Markings, and Equipment</b></li> </ul>	<p><b>4:</b> <b>Good</b></p>

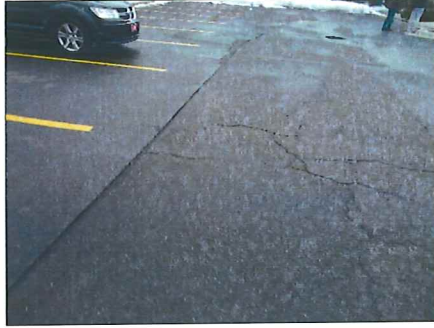
<p style="text-align: center;">Parking Across the Street</p>
<p>No onsite parking is available. There are two loops for drop-off and pick-up only. Parking is available across the street, at meters or at other City locations. Parking lots has cracking is asphalt.</p>

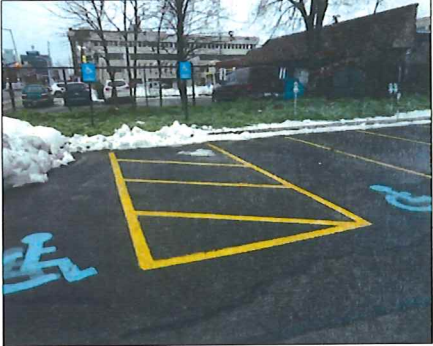
<p style="text-align: center;">Barrier Free Parking</p>
<p>Barrier Free spaces provided in parking is provided along the curb and the lot across Rose Street but there isn't a direct cross walk. Pedestrians have to walk to Kalamazoo Avenue intersection to cross.</p>		<ul style="list-style-type: none"> <li>• <b>Pedestrian Areas and Associated Signage, Markings, and Equipment</b></li> </ul>
<p>No striped crosswalk to parking area across Park Street. City curb cuts are satisfactory.</p>	<p><b>4: Good</b></p>

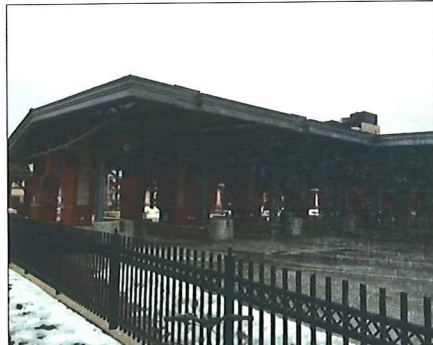
<p style="text-align: center;">Fence Along Bus Canopy</p>
		<p>The plaza area between the bus loading is open and attractive complete with benches for sitting and gathering.</p>

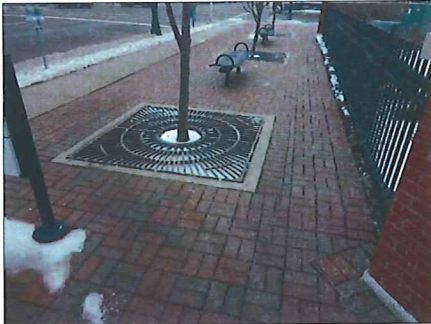
<p style="text-align: center;">Areas of Landscaping</p>
<p>Landscaping is irrigated and appears to be well maintained.</p>		
<ul style="list-style-type: none"> <li>• <b>Site Utilities</b></li> </ul>	<p><b>3: Adequate</b></p>

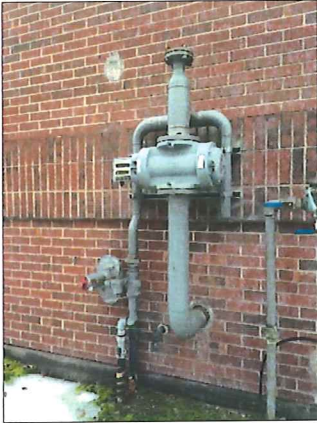
<p style="text-align: center;">Gas Service</p>
<p>Water, sanitary and sewer is provided by the City of Kalamazoo. Natural gas distribution is provided by Consumers.</p>
